### RAPSODI Project

Risk Assessment and design of Prevention Structures  
for enhanced tsunami Disaster resilience

Deliverable D2 Review of post–tsunami field surveys (run up, flow depth, flow velocities, fluxes), damages, and fatalities of the 2011 Tohoku tsunami  
1<sup>st</sup> year of funding

20120768–02–R  
30 April 2015  
Revision: 0

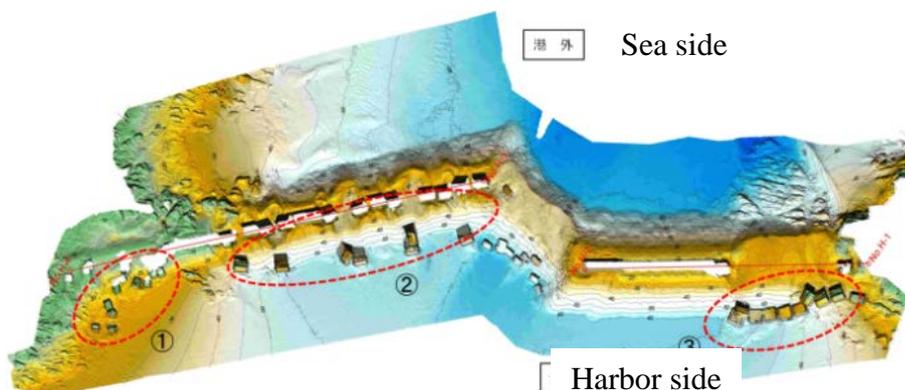
Fig. 2.9 shows the state of damage to all the breakwaters, while Fig. 2.10 and Fig. 2.11 show the crest and the deep sections, respectively, of the North Breakwater in greater detail. These detailed views illustrate how in the deep part of the North Breakwater, many of caissons slid without tilting at all. Finally Fig. 2.12 compares cross-sections of the breakwaters before and after the disaster. On the North Breakwater, the mound level was scoured from 5m to 10m.

Fig. 2.9 State of damage of breakwater (Takahashi et al., 2011).

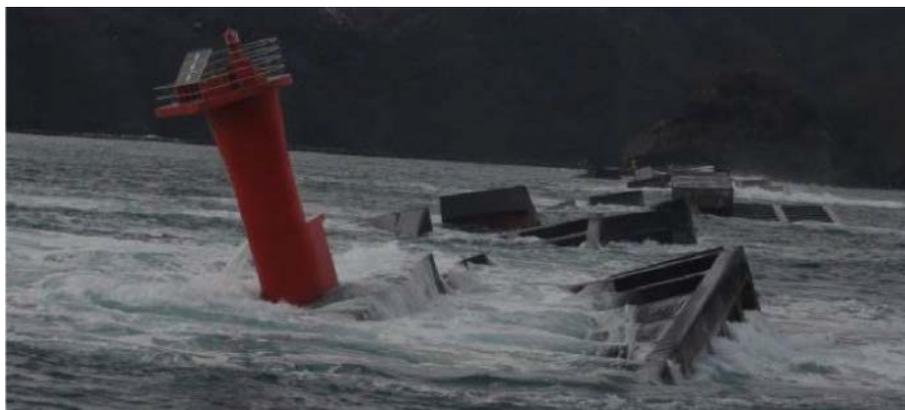
Fig. 2.10 State of damage of North Breakwater (Takahashi et al., 2011).

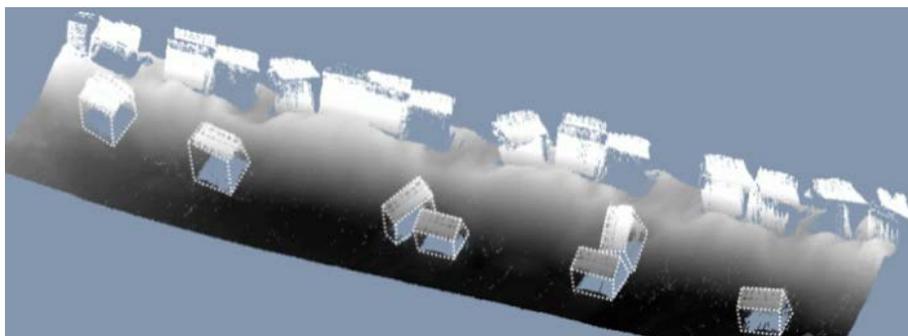
Fig. 2.11 State of damage of North Breakwater (Arikawa et al., 2012).

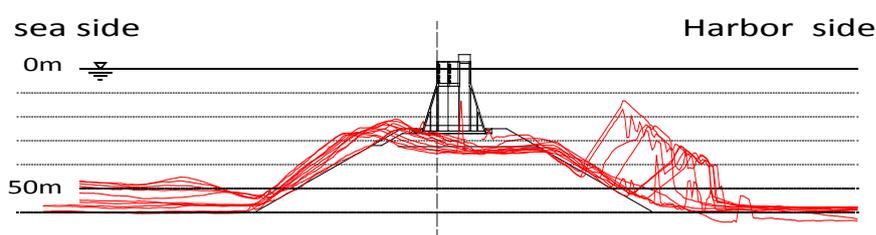
Fig. 2.12 Cross section of damage of North Breakwater (Arikawa et al., 2012).

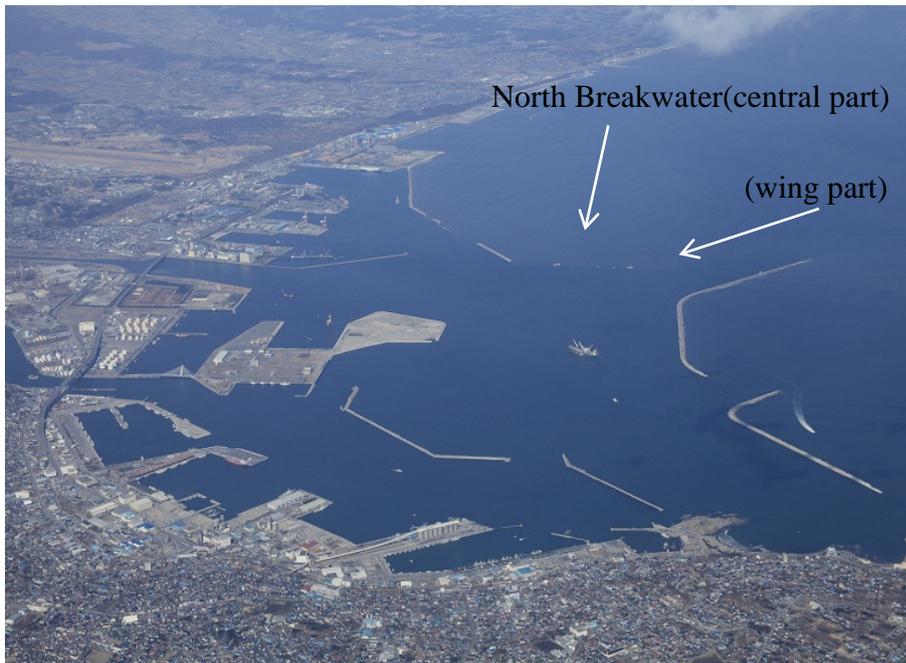
As shown in Table 2.2, many common breakwaters are damaged by tsunami wave force, but many others are presumably damaged by overflow scouring. Fig. 2.13 shows conditions after damage at Hachinohe Port. Here, the Northern Breakwater was severely damaged. Damage to the entire Northern Breakwater occurred, including toppled caissons (44), disrupted wave absorption blocks, scoured foundation mound over the entire 700 m length of the breakwater. Many of the toppled caissons fell over into the shipping channel (maximum moved distance of about 90 m). Behind near the crest of the breakwaters, the sea bed foundation was locally severely scoured. Main caissons (60), which formed about 50% of the Northern Breakwater (center part), were toppled vertically for along a length of 750 m. Many of the toppled caisson leaned. Another particularly characteristic feature was the scouring of the foundation mound and foundation bedrock at the back surface of the caissons; even where the caissons themselves remained relatively undisturbed.

Fig. 2.13 State of damage at Hachinohe Port (courtesy by Tohoku Regional Bureau).

This example at Hachinohe illustrates that more effective countermeasures for overflow scouring are needed. The data show that scouring of the foundation mound is severe and a common type of damage. This damage is assumed to be a result of overflow of the breakwater. While not all caissons were displaced during the tsunami, this type of scouring behind breakwaters was found almost everywhere in the harbor. In turn, the bearing capacity of the mound was insufficient, and caissons were

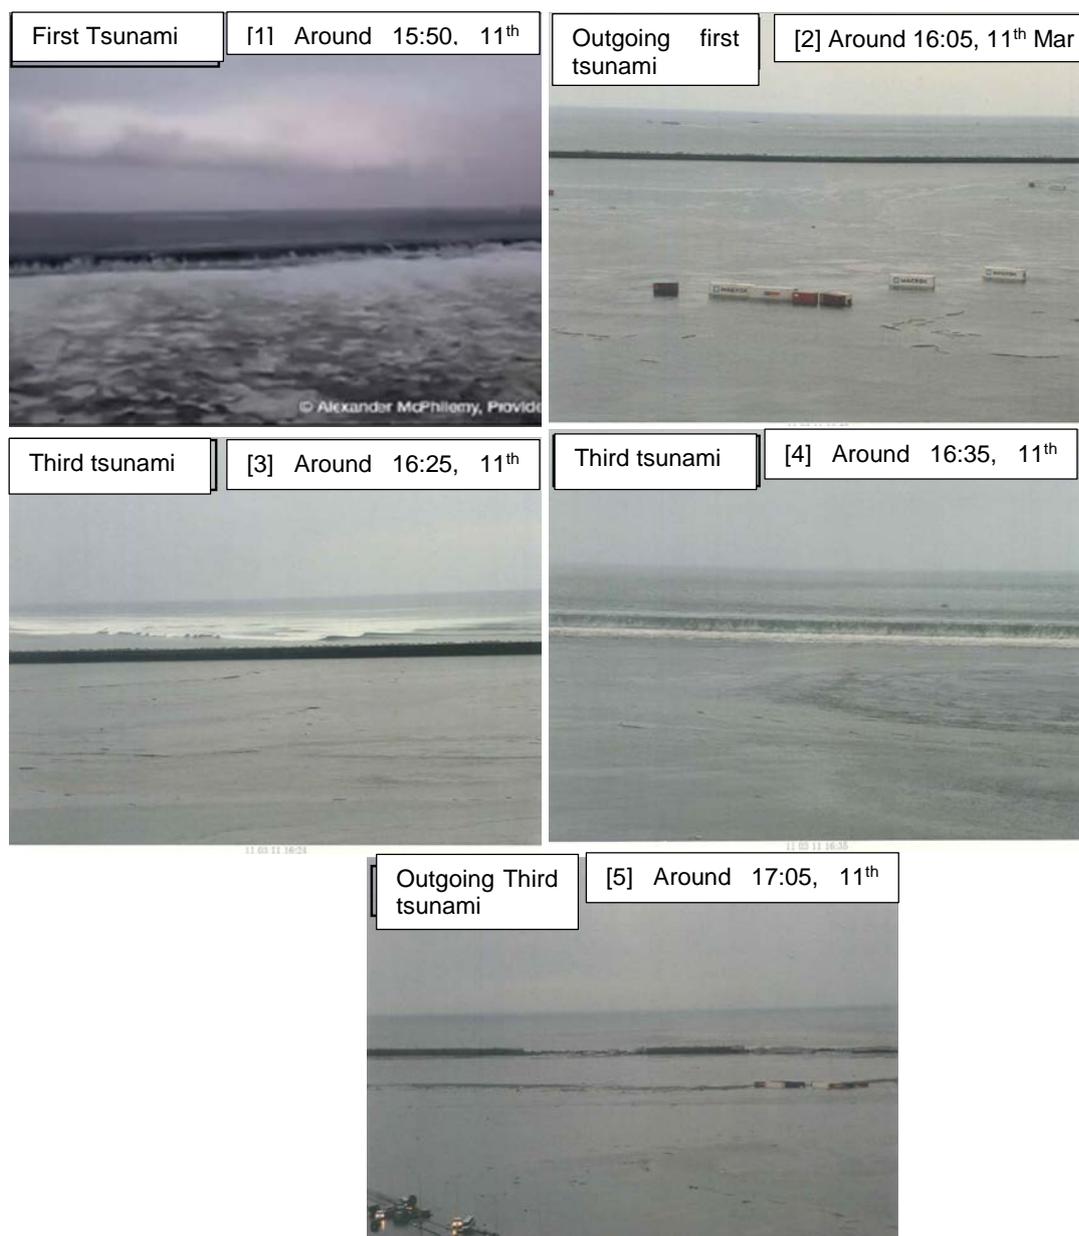
Fig. 2.14 shows the results of a tsunami simulation near the Northern Breakwater in Hachinohe Harbor, and Fig. 2.15 show photos of central part of the breakwater during the real tsunami event at times corresponding to [1] to [5] in the Fig. 2.14.

Fig. 2.15 Photos of the central portion of the harbor at different time intervals.

Simulation results indicate that all breakwaters remained in good condition up to at least the first wave, but the caissons were damaged when the third wave overflowed at 16:35.

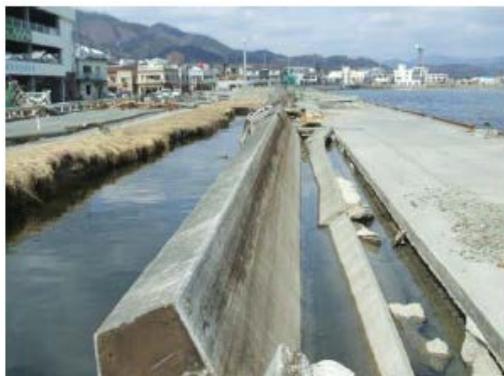
As shown in Fig. 2.16, scouring was observed in almost all the damaged cases, and sometimes sediment was flowing out from foundation due to piping. In Ofunato port, severe scouring would be observed, because drainage was concentrated where the facilities were collapsed due to the backrush.

(a) *Seawalls collapsed towards land*

(Chayamae district, coastal protection area in Ofunato port)(Crest height of walls: TP +3.40m, Observed tsunami height: TP +8.07m)

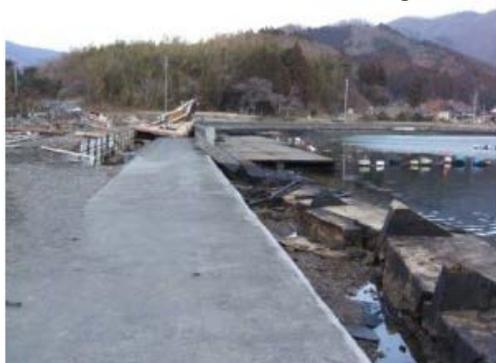
(b) *Seawalls collapsed towards the sea*

(Nagahama district, coastal protection area of Ofunato port)(Crown height of wall: TP +3.00m, Observed tsunami height: TP +10.02m)

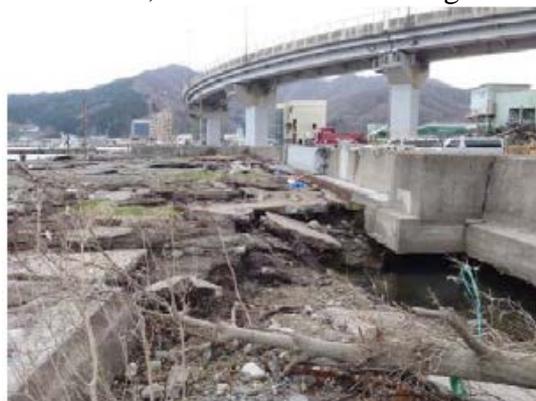
(c) *Severe scouring was observed on the seaside*

(Suga district, coastal protection area of Kamaishi port)(Crown height of wall: TP +4.00m crown high parapet, Observed tsunami height: TP +8.64m)

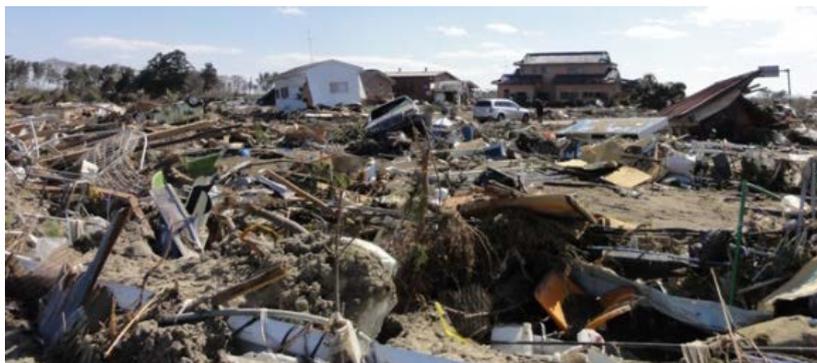
Fig. 2.17 shows a view of the land around Natori City in Miyagi Prefecture. The inundation depth of the tsunami (height of tsunami above the ground) was about 2 m, and while some houses survived, most were washed away. Of those which remained in place, many were damaged as shown in Fig. 2.18. This is interpreted as evidence of large impact force. In the hinterland near the coastline and on sand dunes in particular, breaking bores occur easily, raising the impetus of a tsunami and increasing its destructive force (Arikawa et al., 2006). If the impact force of the wave exceeds the strength of the front face of the house, the building will likely be destroyed by the leading edge of the tsunami before buoyancy begins to act.

*Fig. 2.17 Damaged property around Natori City.*

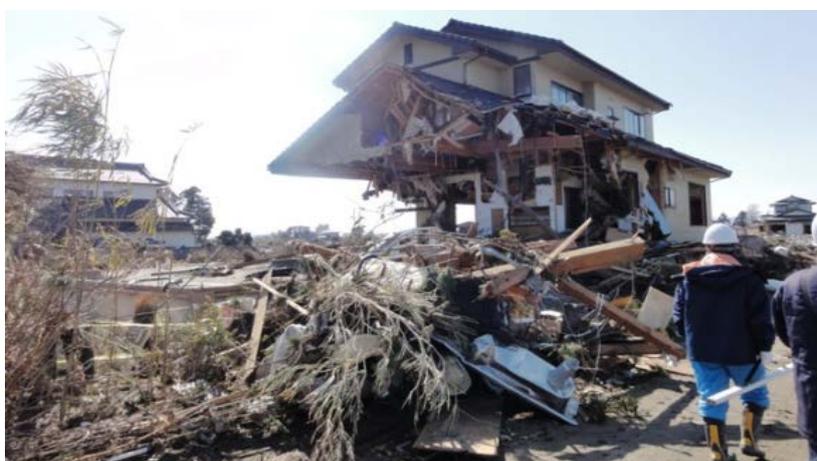
*Fig. 2.18 Damaged property around Natori City.*

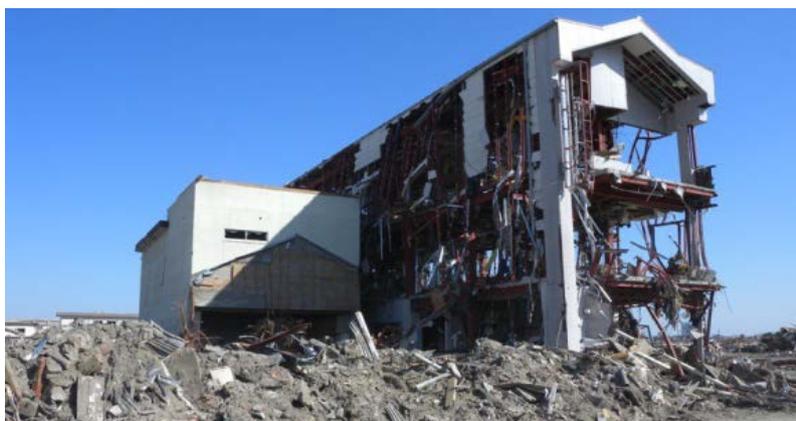
In many steel frame buildings, the front walls are weaker than their columns. Often, the walls are first damaged by the tsunami, which dissipates the force of tsunami, allowing more building occupants to survive. The three-story steel frame building in Fig. 2.19 illustrates this point. While the tsunami reached the ceiling of the third story and the walls were severely damaged, the structure did not collapse.

*Fig. 2.19 Three-story steel frame building in the Rikuzentakada City, Iwate Prefecture.*

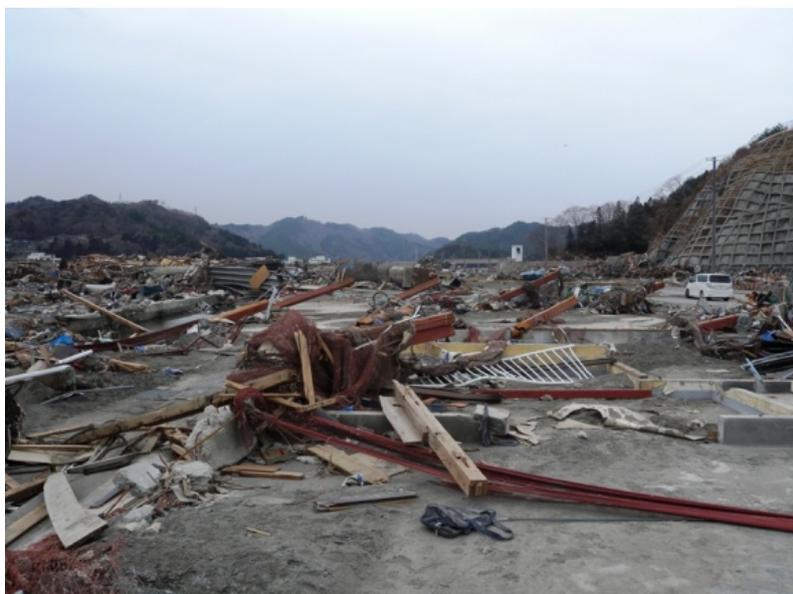
However, if the impact force on the building is large enough, the columns may be broken. In the building shown in Fig. 2.20, the columns were almost all bent in the same direction. The force of tsunami on columns is reduced by their small surface areas, but in cases where they are covered by a large wall, they can all be broken in this way.

*Fig. 2.20 Damage of a steel frame structure in the Ohtsuchi City.*

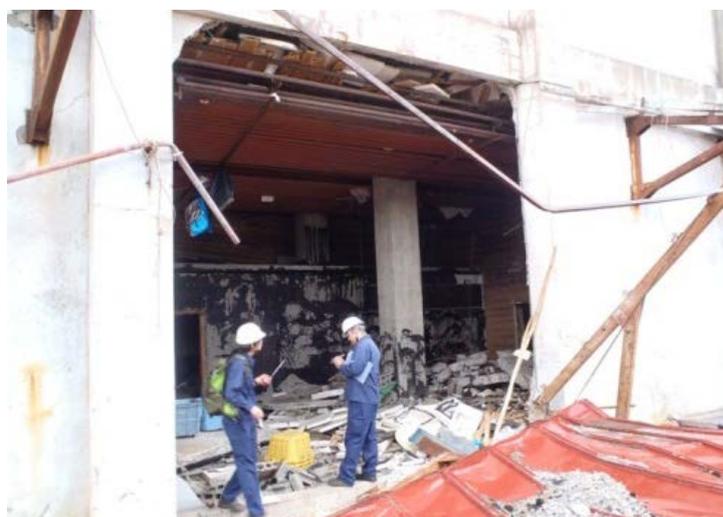
At places where the inundation depth exceeded approximately 8m, even concrete structures may be severely damaged. Walls of box-shaped buildings on the shoreline, refrigerated storage structures or purification plants for example, may be vulnerable. Fig. 2.21 is a view of a refrigerated ice making plant in Kamaishi with a wall pulled out. In this district, the inundation depth was about 8 m, and this was directly behind a revetment. Such buildings resisted the intrusion of tsunami, and there were no debris on the second story. Thus, it is presumed that it was destroyed by water pressure.

*Fig. 2.21 View of a refrigerated ice making plant in Kamaishi with a wall pulled out.*

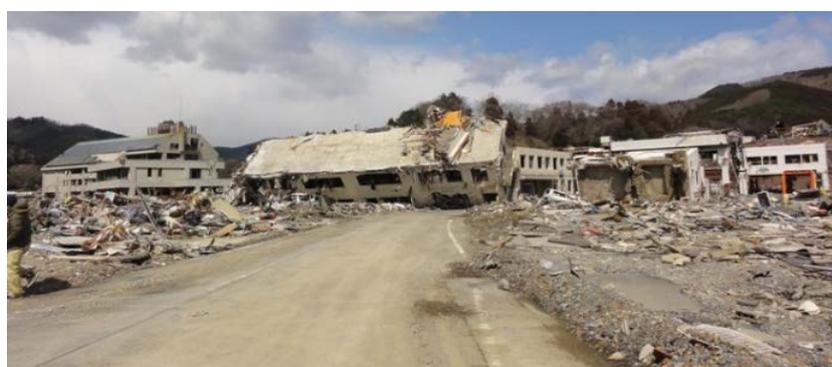
In Onagawa-cho in Miyagi Prefecture, many steel frame and concrete buildings were damaged. Fig. 2.22 shows a three-story apartment building thought to have stood near the quay wall but which was washed away. A collapsed two story police box to

*Fig. 2.22 A three store apartment building that has been washed away (Takahashi et al., 2011).*

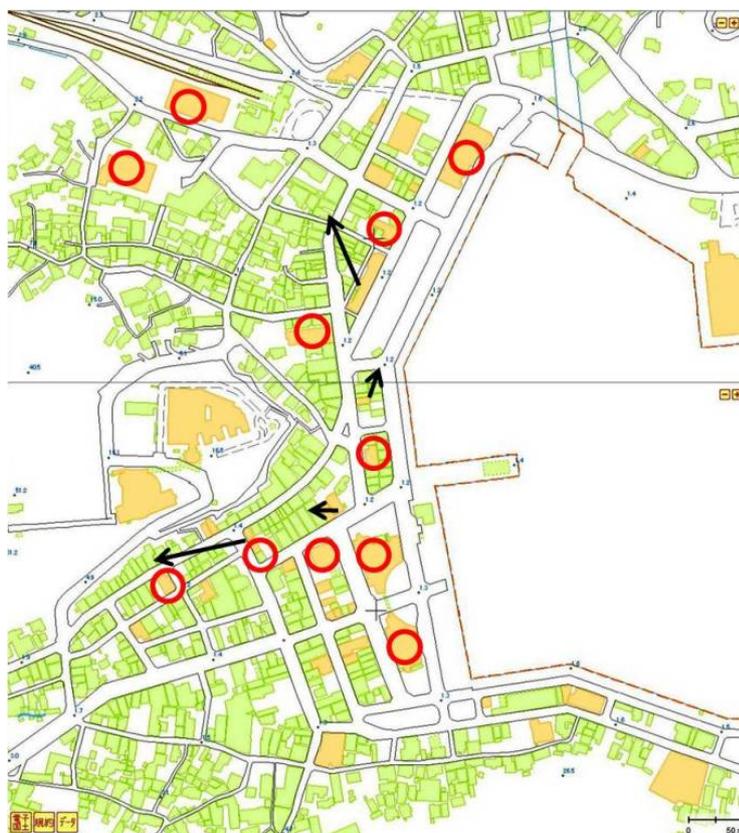
its right. Fig. 2.23 shows damage to buildings of three or more stories around Onogawa Fishing Harbor. Red circles denote the damaged buildings of three or higher stories and the black arrows show assumed washed-away directions of buildings. It is assumed that, as in the case of houses, buoyancy is one of the factors causing these buildings to be washed away, and that this occurred after submersion.

*Fig. 2.23 Damage to buildings of three or more stories around Onagawa Fishing Harbor. Red circles denote the damaged buildings of three or more stories and the black arrows show assumed washed-away directions of buildings (Takahashi et al., 2011).*
