Deliverable D2 *Review* of post-tsunami
field surveys (run up, flow depth, flow
velocities, fluxes), damages, and fatalities
of the 2011 Tohoku tsunami

Port and Airport Research Institute

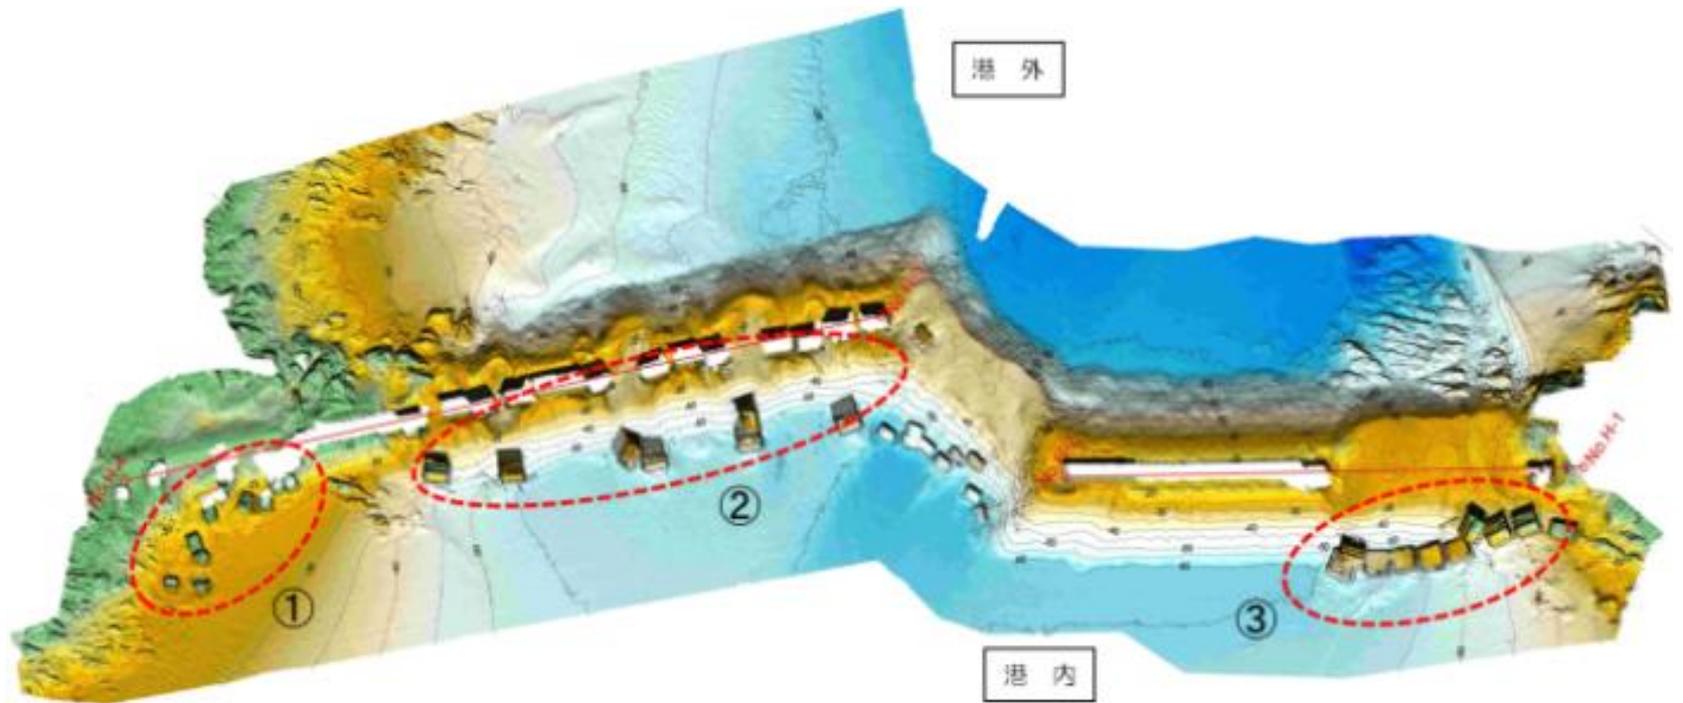
Fig. 2.9 State of damage of breakwater (Takahashi et al., 2011)

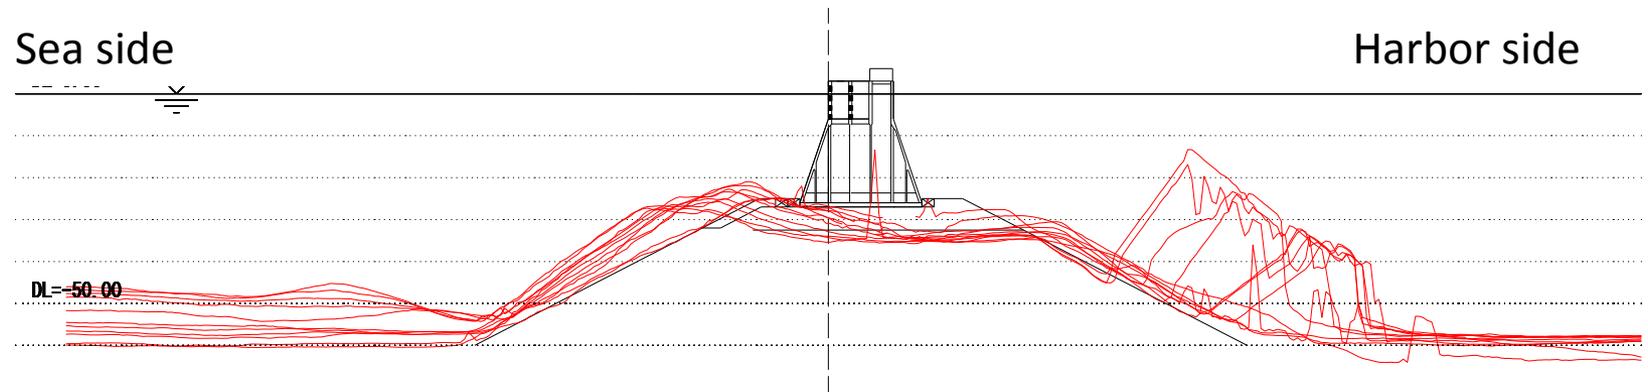
Fig. 2.12 Cross section of damage of North Breakwater (Arikawa et al., 2012)

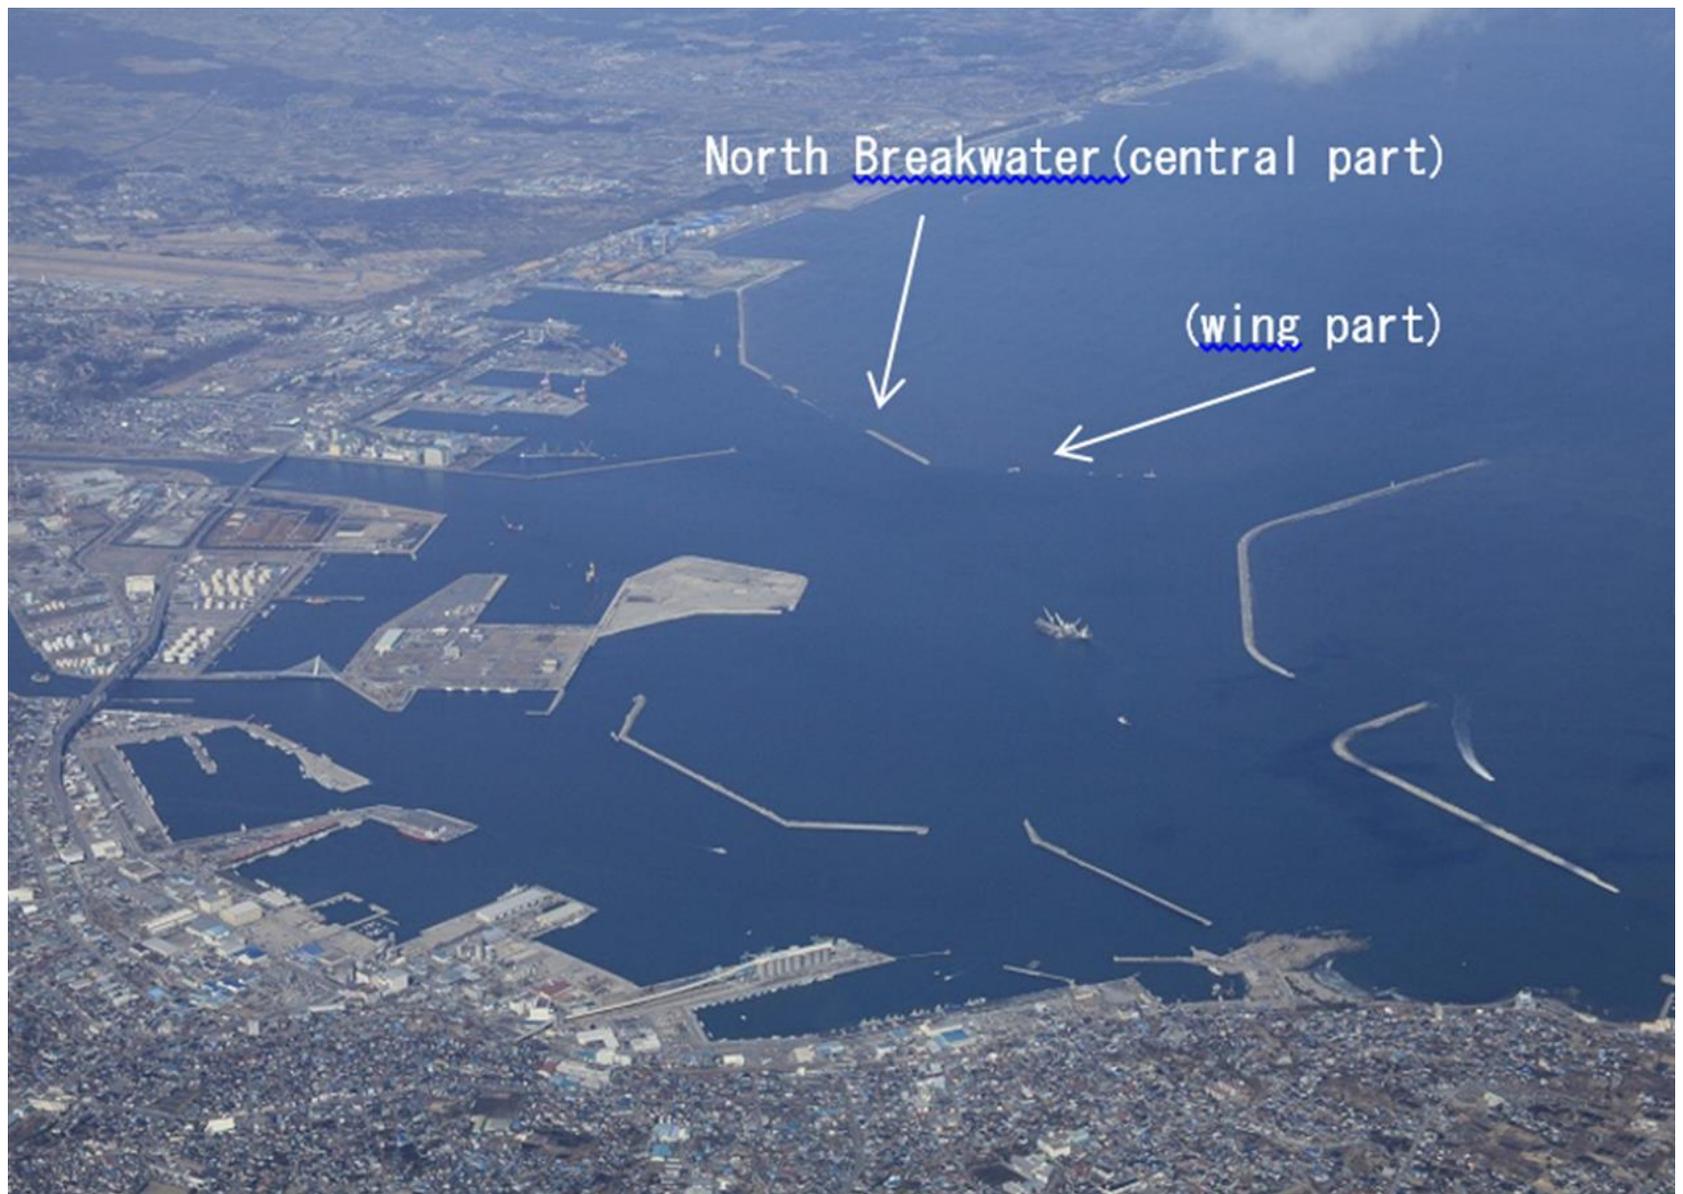
Fig. 2.13 State of damage at Hachinohe Port
(courtesy by Tohoku Regional Bureau)

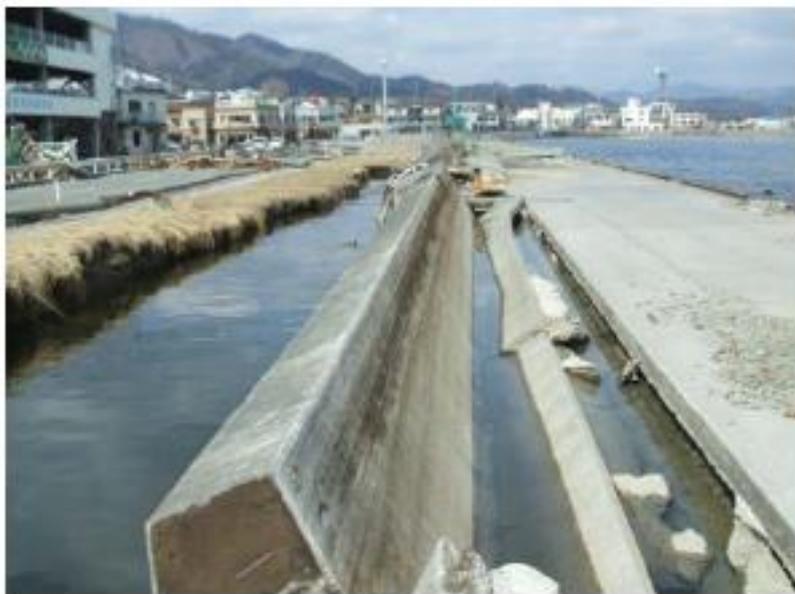
(a) Seawalls collapsed towards land
(Chayamae district, coastal protection area in Ofunato port)(Crest height of walls: TP +3.40m, Observed tsunami height: TP +8.07m)

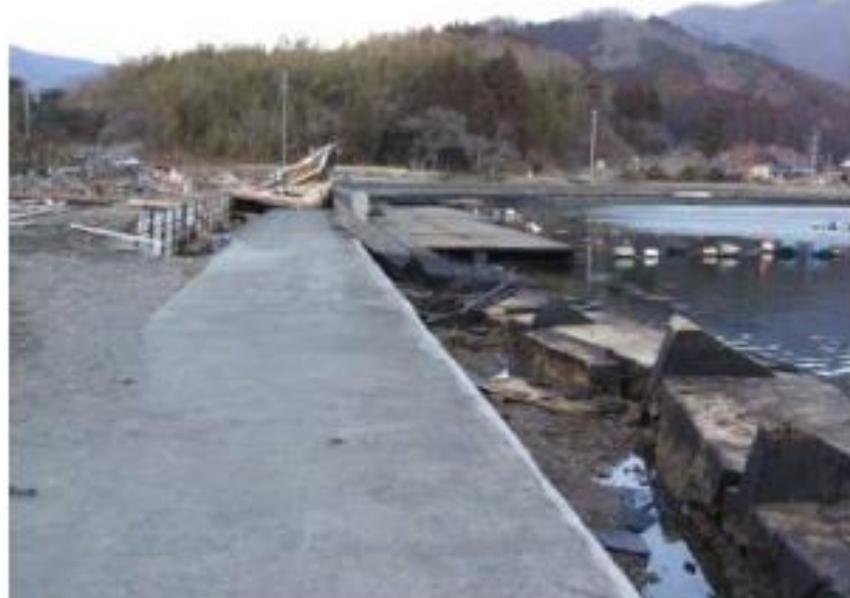
(b) Seawalls collapsed towards the sea
(Nagahama district, coastal protection area of Ofunato port)(Crown height of wall: TP +3.00m, Observed tsunami height: TP +10.02m)

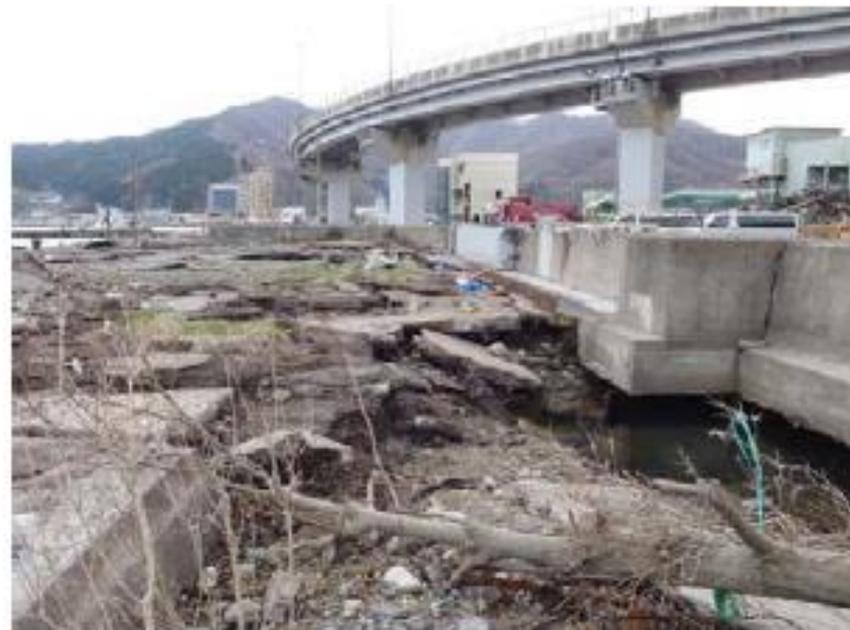
(c) Severe scouring was observed on the seaside
(Suga district, coastal protection area of Kamaishi port)(Crown height of wall: TP +4.00m crown high parapet, Observed tsunami height: TP +8.64m)

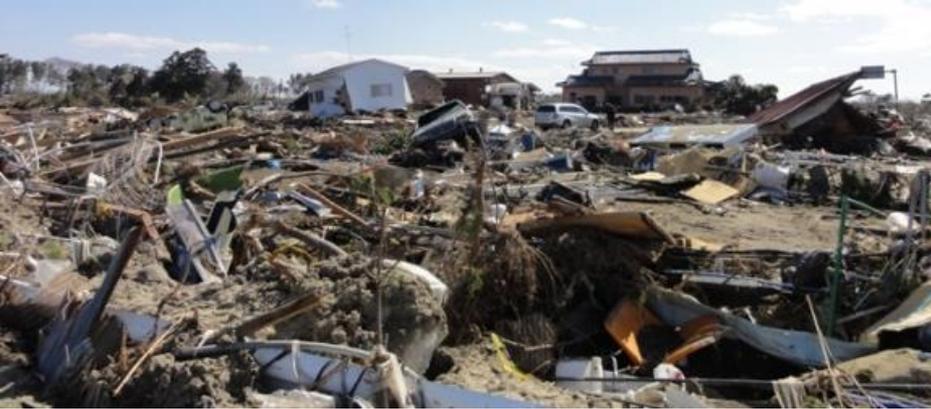
Fig. 2.17 Damaged property around Natori City

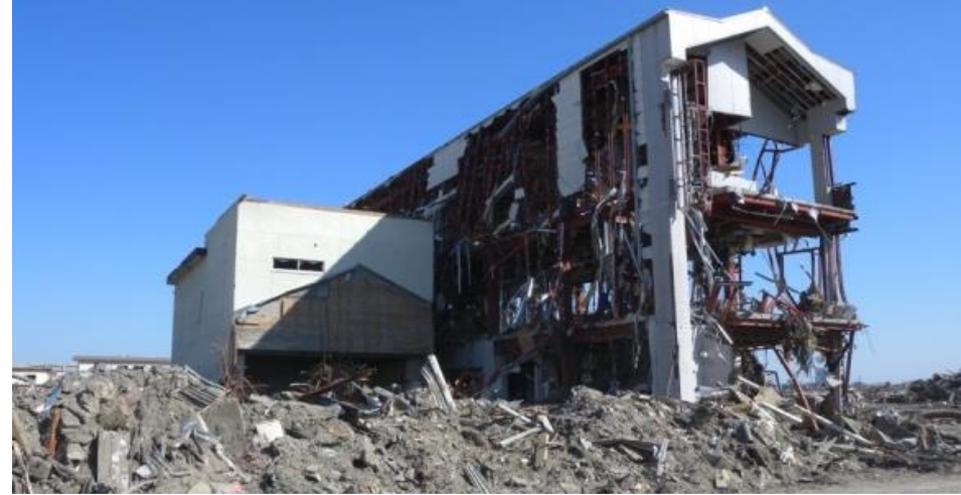
Fig. 2.19 Three-story steel frame building in the Rikuzentakada City, Iwate Prefecture

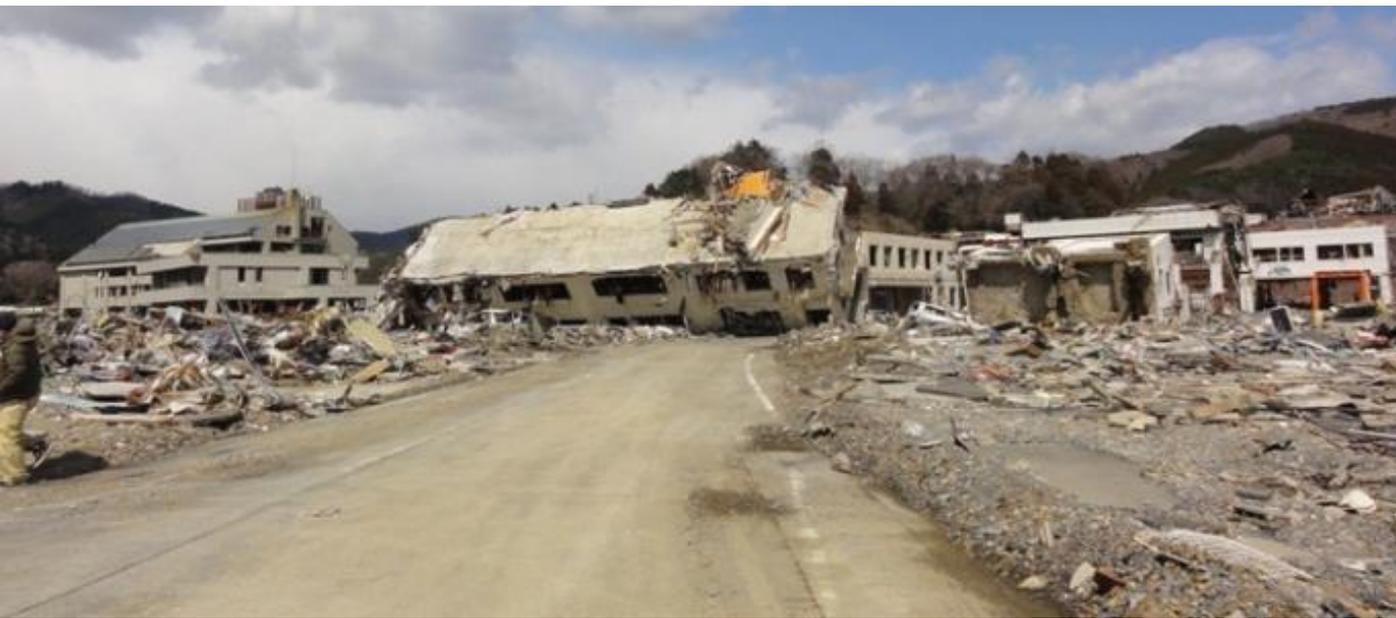
Fig. 2.22 A three store apartment building that has been washed away (Takahashi et al., 2011)
