Pictures from the quick clay slide in Rissa, Norway 29 April 1978

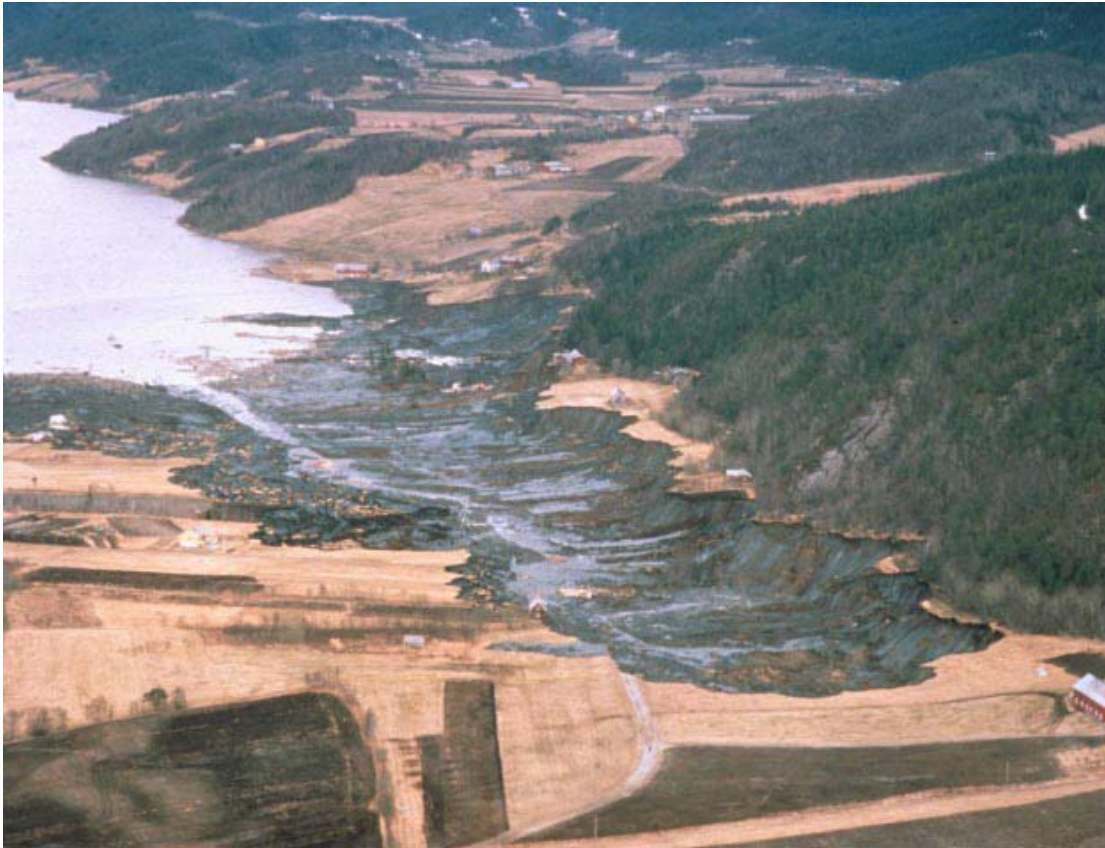
Above: Areal view of the slide from the south

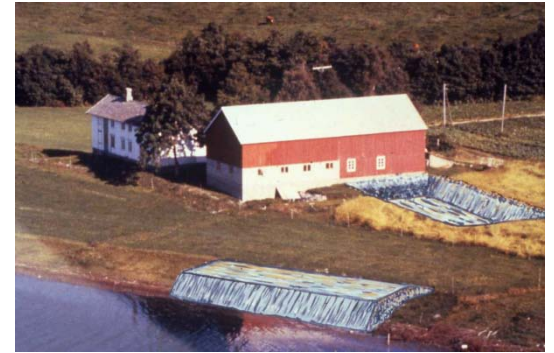
Top right: The cause of the slide; excavation material for extension of farm house placed along shoreline of lake. The barn can be seen on the northern edge of the slide on the large picture

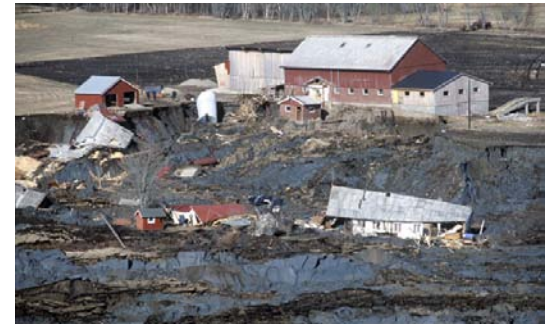
Middle right: Demolished farm along western slide scar

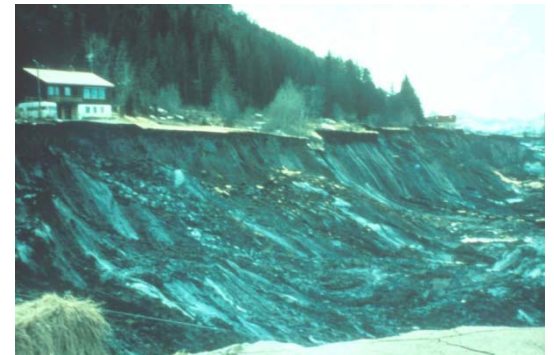
Bottom right: Eastern slide scar towards south
