To: NVE
Attn.: Odd-Arne Jensen
Copy to:
Date: 2021-03-22
Revision no./Rev.date: 0 /
Document no.: 20200017-05-TN
Project: AARN - Applied Avalanche Research in Norway
Project manager: Christian Jaedicke
Prepared by: Peter Gauer, Henrik Langeland
Reviewed by: Henrik Langeland

WP 2 – Full-scale experiments at Ryggfonn Ryggfonn avalanche observations 2019/2020

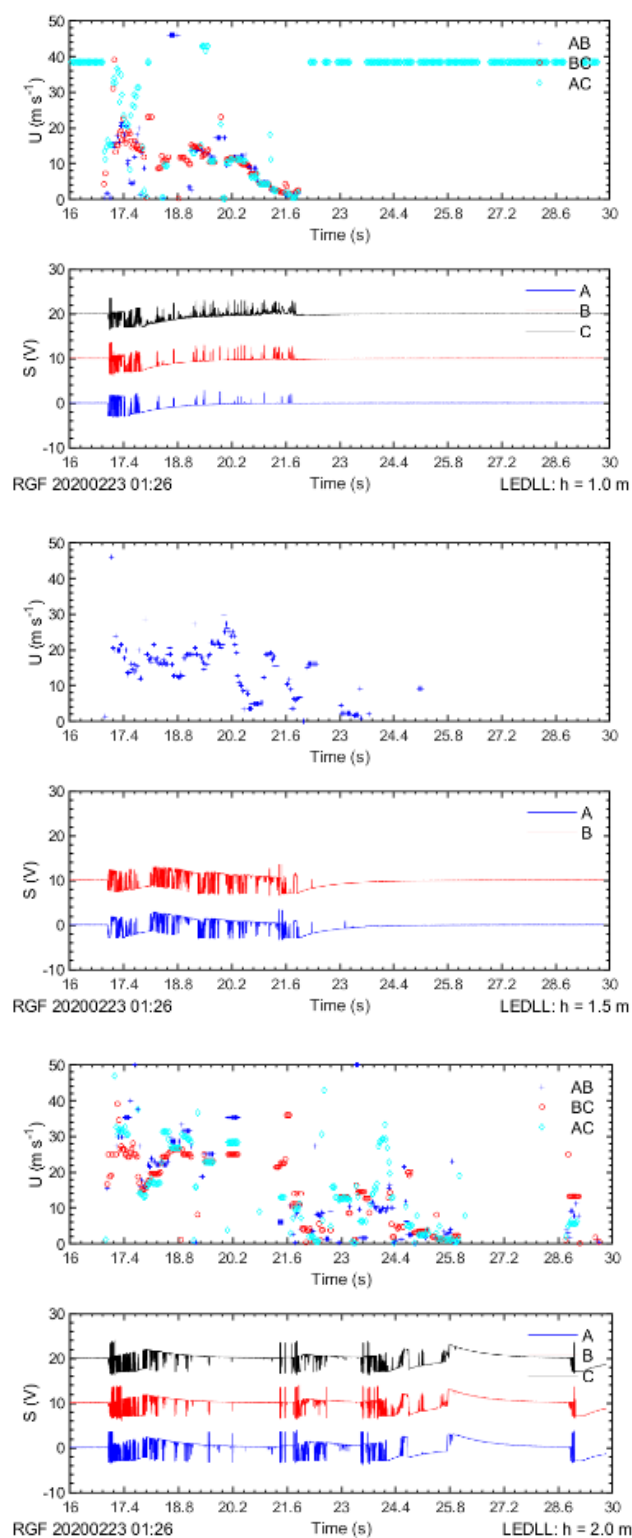
Figure 13 Preliminary velocity (U) estimates based on cross-correlated LED-data at 1.0, 1.5, and 2.0 m above ground. In addition, the raw data of the led-sensors are plotted.

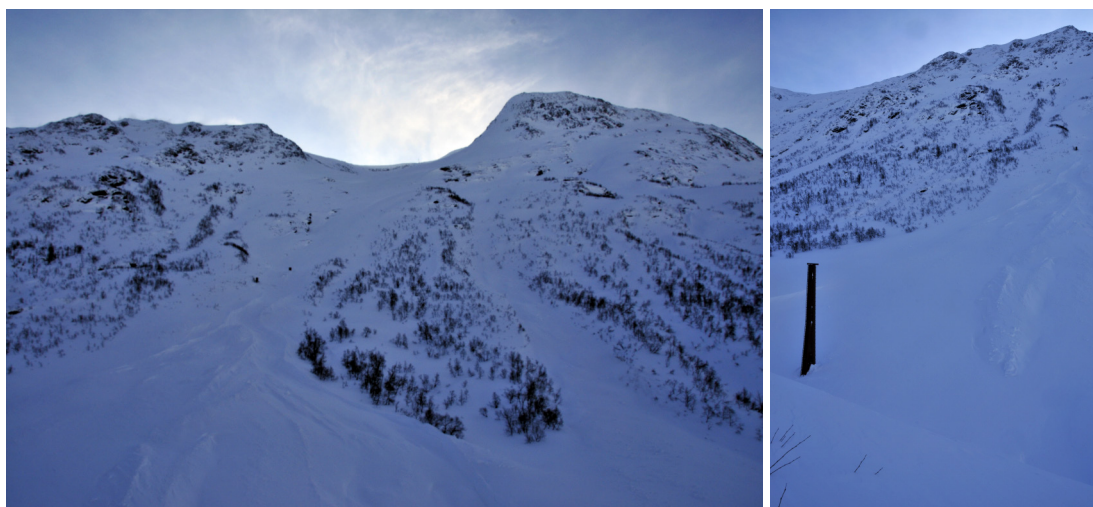
Figure 14 Track of the 2020-02-23T01:16 event; photo taken on afternoon of 2020-02-26 (photos Henrik Langeland).

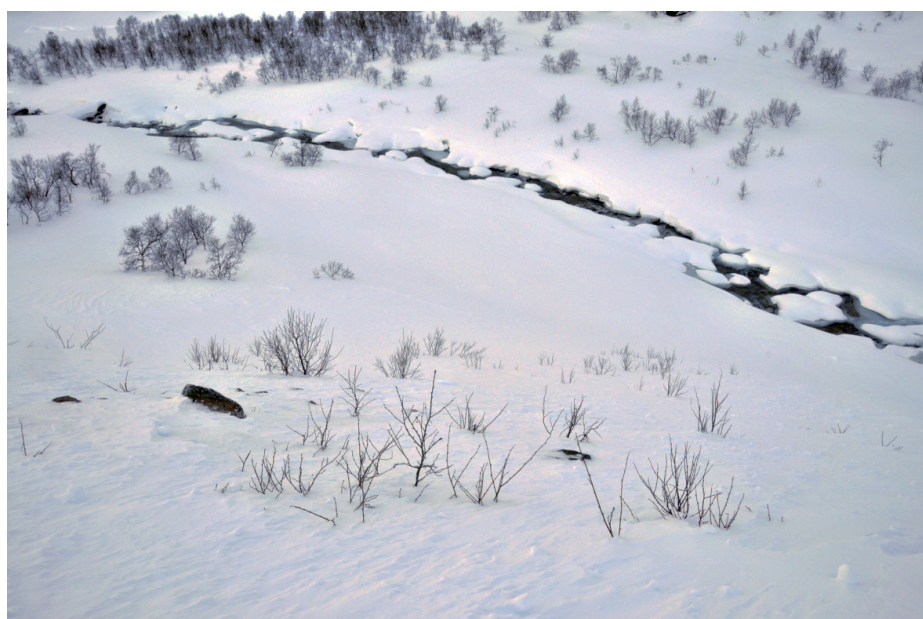
Figure 15 Back side of the dam after the 2020-02-23T01:16 event (photo Henrik Langeland 2020-02-26).

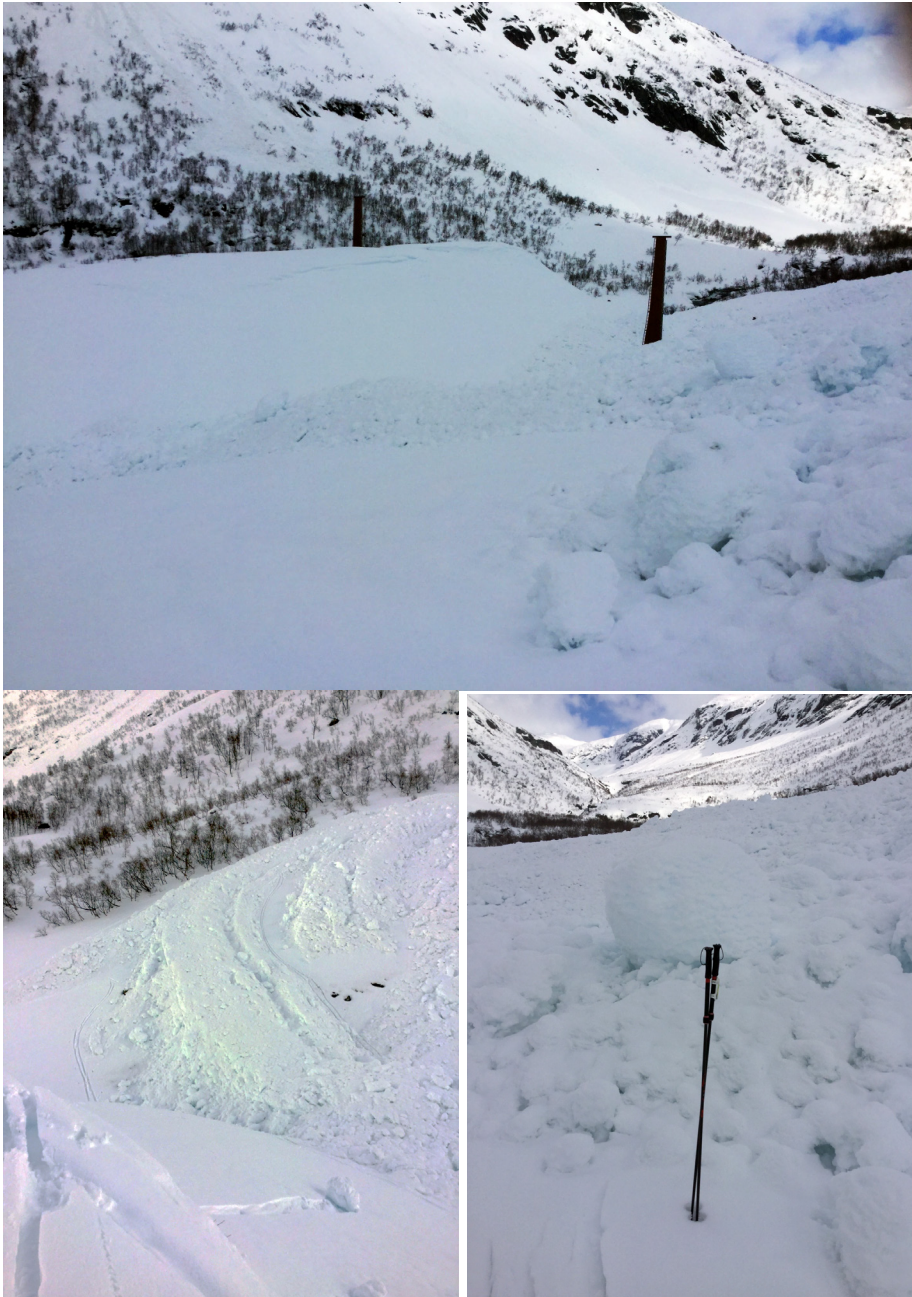
Figure 17 Deposition area of the 2020-03-24T13:53 event; photo taken on afternoon of 2020-03-26 (photos Henrik Langeland).

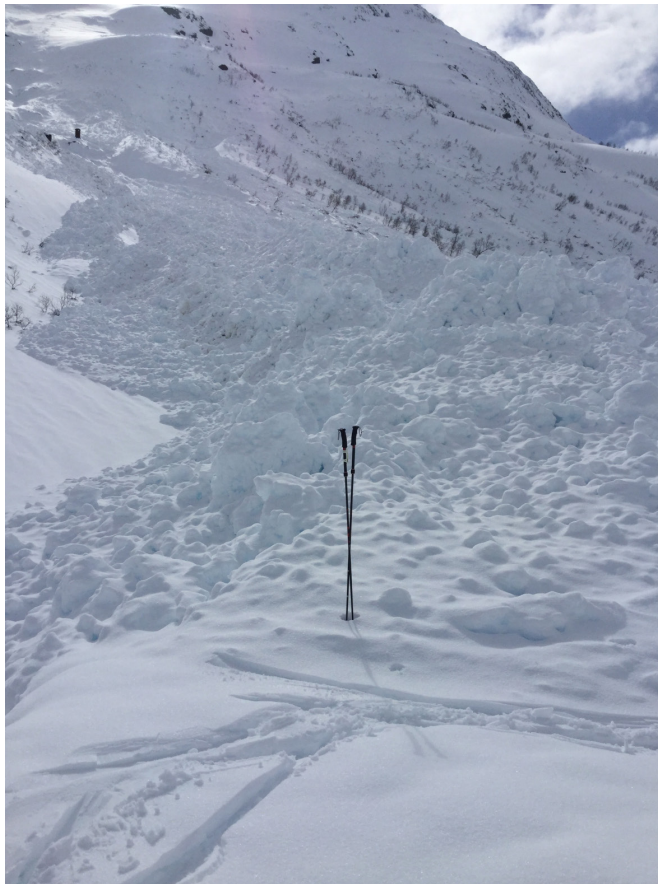
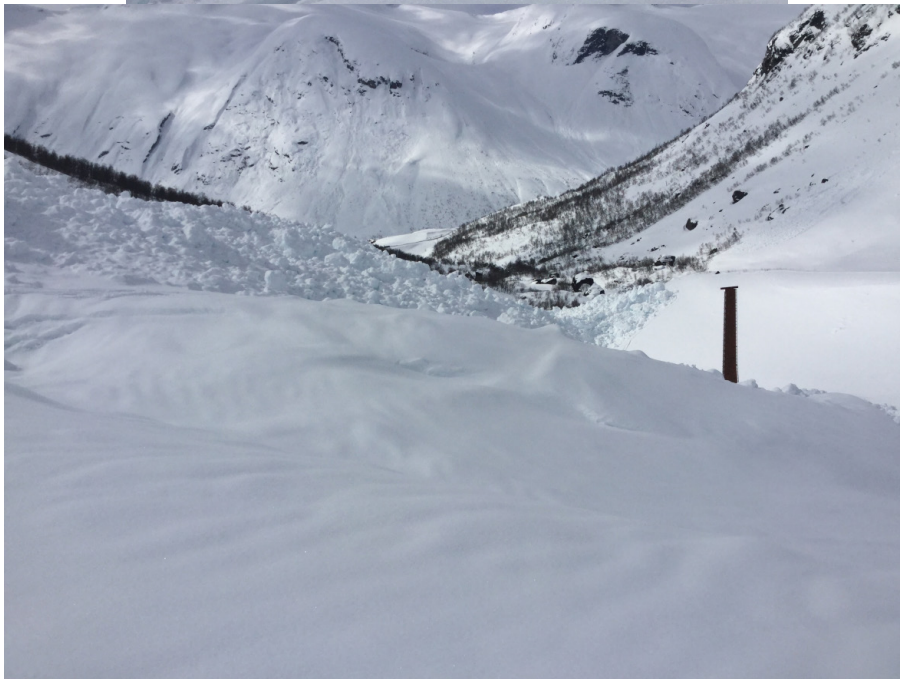
Figure 22 Deposition area of the 2020-04-15T16:55 event; photo taken on morning of 2020-04-18 (photos Henrik Langeland).
