### RAPSODI Project

Risk Assessment and design of Prevention Structures  
for enhanced tsunami Disaster resilience

Deliverable D2 Review of post–tsunami field surveys (run up, flow depth, flow velocities, fluxes), damages, and fatalities of the 2011 Tohoku tsunami  
1<sup>st</sup> year of funding

20120768–02–R  
30 April 2015  
Revision: 0

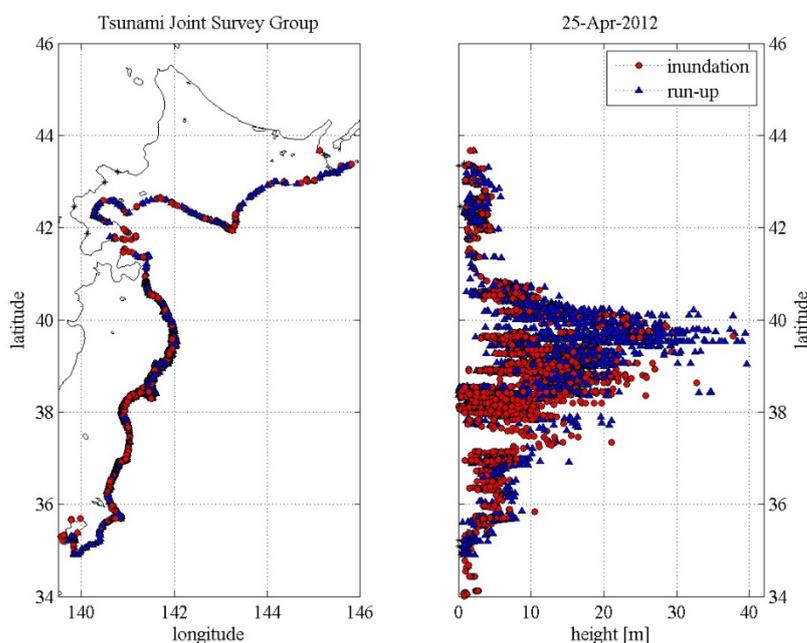
The Tohoku earthquake Tsunami Joint Survey Group assembled 50 organizations (150 people or more) for a field study. From March 12th to May 22th, 2011, tsunami-affected areas along the Pacific coast from Hokkaido to Okinawa Prefecture were surveyed. The largest tsunami heights were recorded north of 34°N (Fig. 2.1). Tsunami heights and inundation heights were recorded separately, as reflected in Fig. 2.1. In this study, inundation height is defined as a water level measured above the sea level, and run-up height denotes the maximum trace of tsunami measured above the sea level.

Note that inundation *depth* is defined as a height of tsunami above the ground (for these definitions, see Fig. A1 in the Appendix). The trace of the tsunami exceeded a height of 10 m on a 530 km stretch of coastline centered on Iwate Prefecture over about 530 km. In addition, tsunami trace heights exceeding 20m were recorded in most locations along the Sanriku coast, a typical Rias coast. Furthermore, run up heights of 40 m were confirmed in Ryori Bay at Ofunato City, making this the maximum tsunami height recorded in Japan.

Fig. 2.1 Distribution of trace of tsunami height by the 2011 Tohoku earthquake Tsunami Joint Survey Group (2012). (Only high-confidence data are included; the date above the right panel gives the time for the last update of survey data).

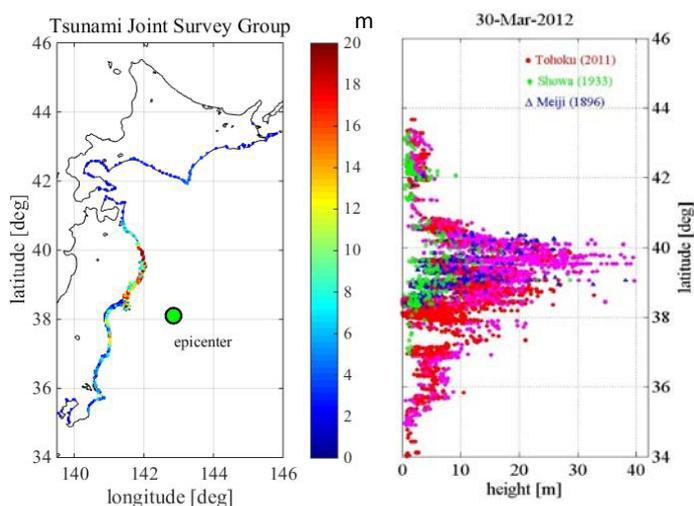
Fig. 2.2 shows the comparison with tsunami height of past events. It indicates tsunami heights in the Iwate prefecture were similar to levels observed in the 1896 Meiji Sanriku tsunami, whereas those in the southern Tohoku region were much larger.

*Fig. 2.2 Left panel: Distribution of tsunami height for 2011 event (color denotes level of tsunami height). Right panel: Comparison of tsunami height between the 2011 event and previous events (purple color denotes run-up height and red inundation height). Left panel from Mori et al. (2012); The 2011 Tohoku Earthquake Tsunami Joint Survey (TTJS) Group (2012); the date above the right panel gives the time for the last update of survey data.*

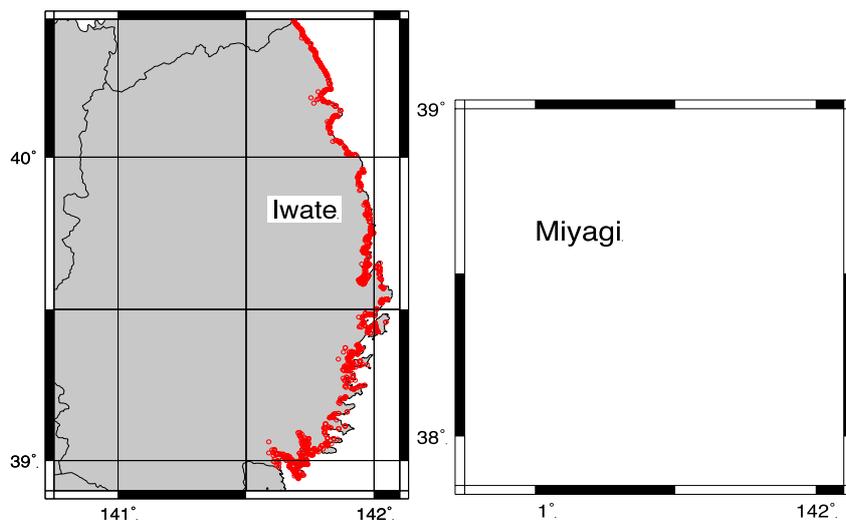
The run up points of Iwate and Miyagi prefecture are shown in Fig. 2.3. In the Iwate prefecture, the run up coordinates are near the coast because of the mountain range close to shore. In contrast, the topography of Sendai area is flat, so the run up or the end of inundated area is very far from coastal line.

Fig. 2.3 Tsunami run up points at Iwate and Miyagi prefecture.

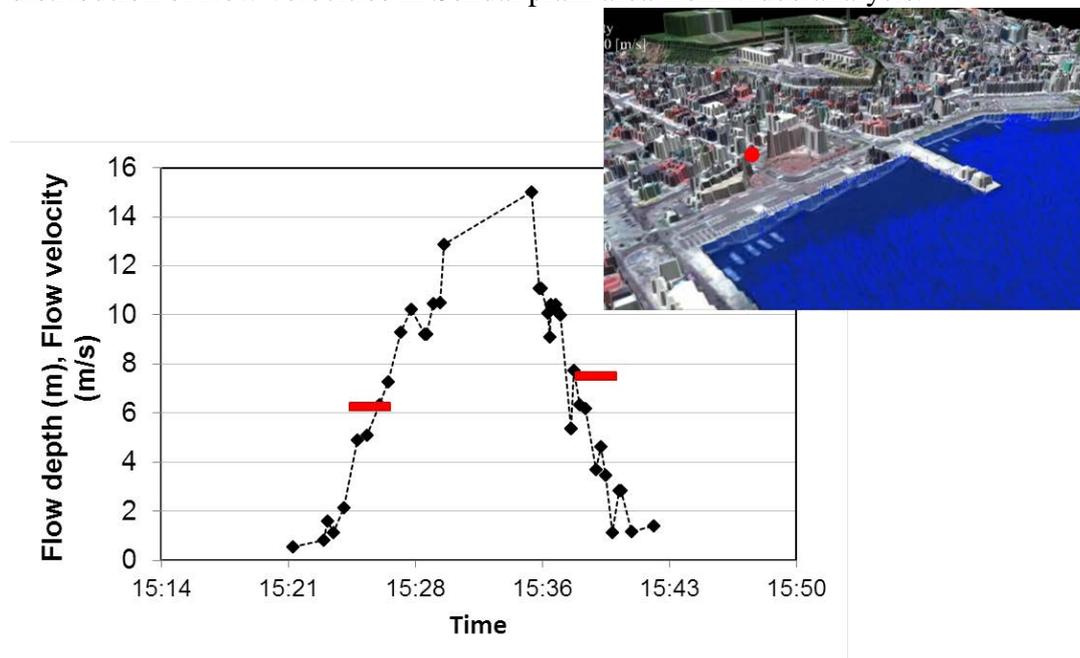
Many researchers analyzed the flow velocity using video recordings of the event. For example, Koshimura et al. (2011) conducted the video analysis at the city of Onagawa, and calculated flow depth and velocity (Fig. 2.4). They indicated that the flow depth increased with 1 to 2 m/s vertical speed. However, this was highly dependent on local topography. Hayashi and Koshimura (2012) also estimated aerial distribution of flow velocities in Sendai plain area from video analysis.

Fig. 2.4 Video analysis of flow depth and velocity near the coast line at Onagawa. Dots are flow depth while red lines denote mean flow velocities (Koshimura et al. 2011).

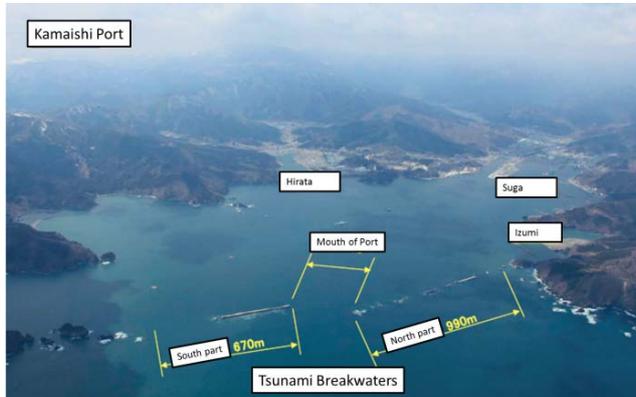
The Kamaishi Bay mouth breakwaters include the North Breakwater (length 990 m), South Breakwater (length 670 m), and the Bay Mouth section (length 330 m) as shown in Fig. 2.5. The maximum depth at the breakwaters is 63 m.

Fig. 2.5 The Kamaishi Bay mouth breakwaters (courtesy by Tohoku Regional Bureau).

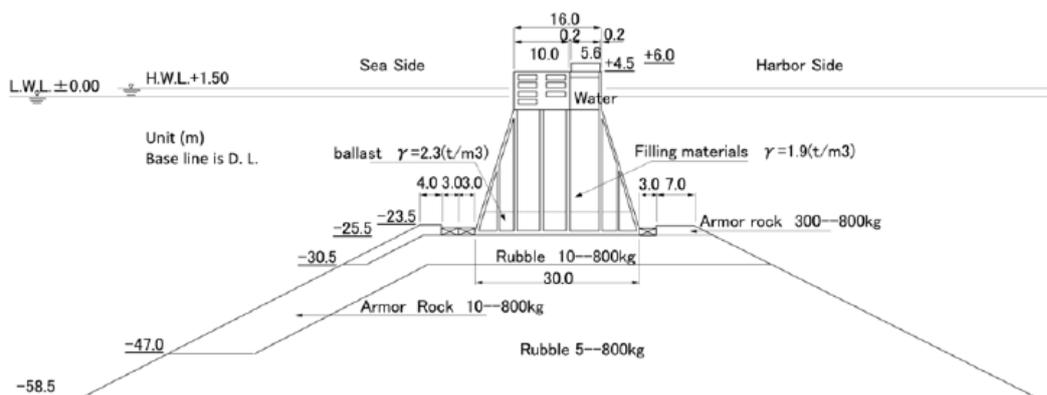
The lowermost portion of the North Breakwater consists almost entirely of trapezoidal caissons shown in Fig. 2.6. Its foundation mound spans an elevation of 60 m to 27 m below sea level. Above it, caissons weighing about 36,000 tons are installed. In shallow parts, the caissons are rectangular with height ranging from 10m to 15m. Similarly, at the South Breakwater, 3 caissons are trapezoidal caissons, but the rest are approximately 32,000 ton rectangular caissons shown in Fig. 2.7. Their crest height is D.L. +6.0m (T.P. +5.14 m), and their foundation mound extends from depth of 55 to 22m below sea level. Finally, at the Bay mouth section, the depth of the submerged breakwater is D.L. -19.0 m (ground level measured from mean low water level), and armor blocks are inserted around it.

Fig. 2.6 Standard Cross section at the deep portion of the North Breakwater (Takahashi et al., 2011).

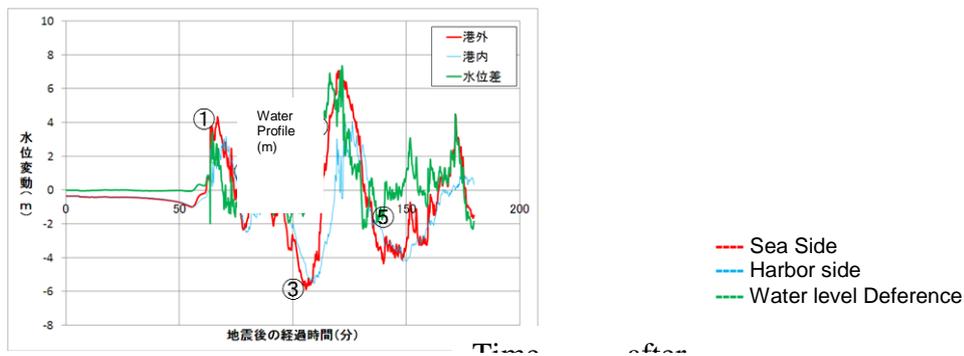
Fig. 2.14 shows the results of a tsunami simulation near the Northern Breakwater in Hachinohe Harbor, and Fig. 2.15 show photos of central part of the breakwater during the real tsunami event at times corresponding to [1] to [5] in the Fig. 2.14.

Fig. 2.14 Result of tsunami simulation at central part of North Breakwater.

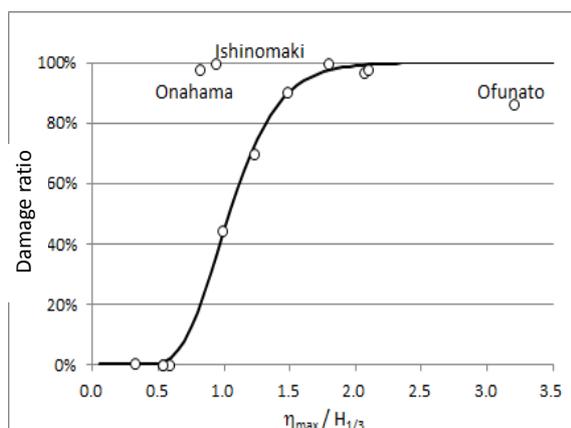
PIANC (2013) shows the relation between the design wave height-tsunami height ratio and the damage ratio (Fig. 2.24). The damage ratio is defined as the ratio of the length of damage-prone breakwaters (subject to damage assessment regardless of the degree of sustained damage) to the length of the front-line breakwaters in the harbors (i.e. = damage length/total length). The solid line represents the cumulative distribution function of the following logarithmic normal distribution:

where  $H_{1/3}$  is the design wave height,  $\eta$  is the tsunami height at the front side of the breakwater, and  $\mu$  and  $\sigma$  are parameters ( $\mu = 0.0386$ ,  $\sigma = 0.279$ ). This reveals that more severe damage occurs when a tsunami height at the front side of the breakwater is equal to or greater than the design wave height. This general result indicates that tsunami force acting on the breakwater was almost the same degree of that of the design wave height. On the contrary, in some limited cases such as Ishinomaki and Onagawa, nearly 100 % damage was observed even under relatively low tsunami height. This was supposed to be caused by the increased water level on the rear side of the breakwater and because the pressure caused by the tsunami was different from what is considered for regular high waves.

Fig. 2.24 Damage ratio of front-line breakwater and tsunami height of different port (PIANC, 2013).

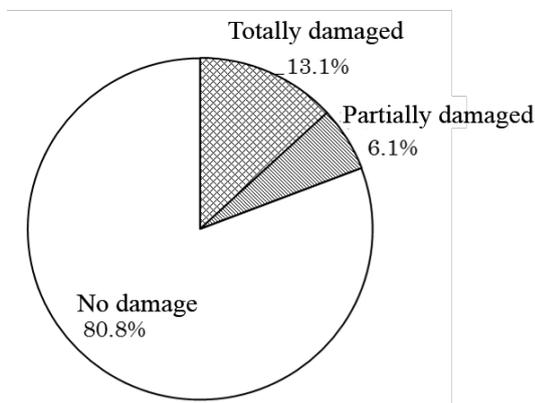
The relationship between the damage ratio and the relative height was investigated on each of the 60 seawall structures between Kuji City and Rikuzentakata City in Iwate Prefecture. Only seawalls where the cross-sectional shape of the structure was known was included in the analysis. The heights of the structures investigated are listed in Fig. 2.25. The damage ratios are given in Fig. 2.26 It is shown that about 20% of breast walls were damaged, including partially damaged ones.

Fig. 2.26 Damage ratios of facilities evaluated.

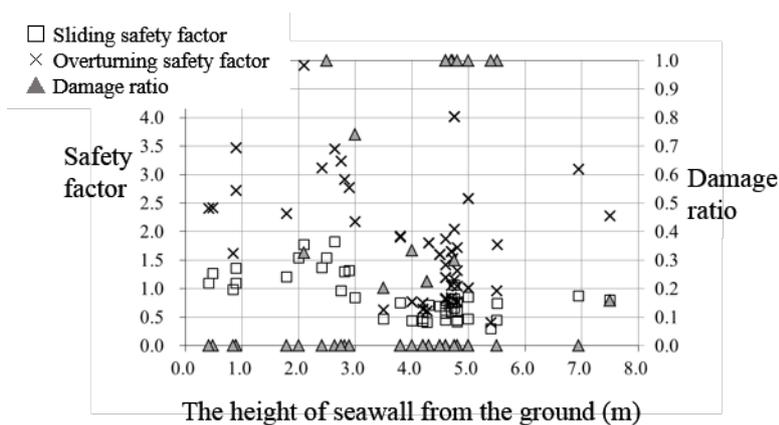
Fig. 2.27 shows the relationship between the safety factors for sliding and overturning, calculated using the wall height paired with the damage ratio and with the crest water level. The relation reveals that the safety factor for sliding was generally lower than the safety factor for overturning and that the safety factor for sliding dropped below 1.0 around where the wall height exceeded 3 meters. The analysis further showed that that the damage ratio reached 1 around where the relative height exceeded 4.0 meters.

Fig. 2.27 Relations between various safety factors based on seawall heights, damage ratios, and crest water levels.

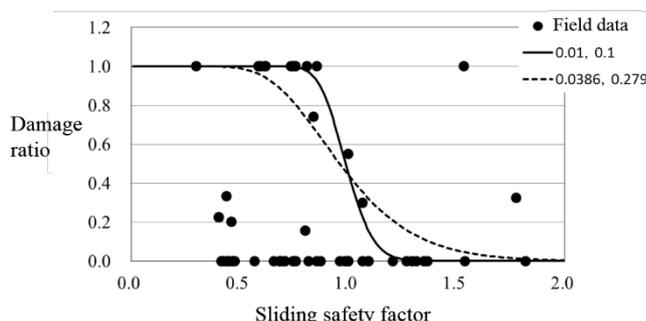
Fig. 2.28 shows the relation between the safety factor for sliding and the damage ratio, together with the cumulative distribution function curves of logarithmic normal distributions. The logarithmic variable is the inverse of the safety factor. One of the two curves is for the same parameters as for breakwaters and the other is for  $\mu = 0.01$  and  $\sigma = 0.1$ . As far as the damaged breast walls are concerned, their values are generally on the curves, which appear sharper than those for the breakwaters. The implication is a nearly 100-percent probability of collapse for a given triggering event.

Fig. 2.28 Relations of safety factor for sliding to damage ratio.

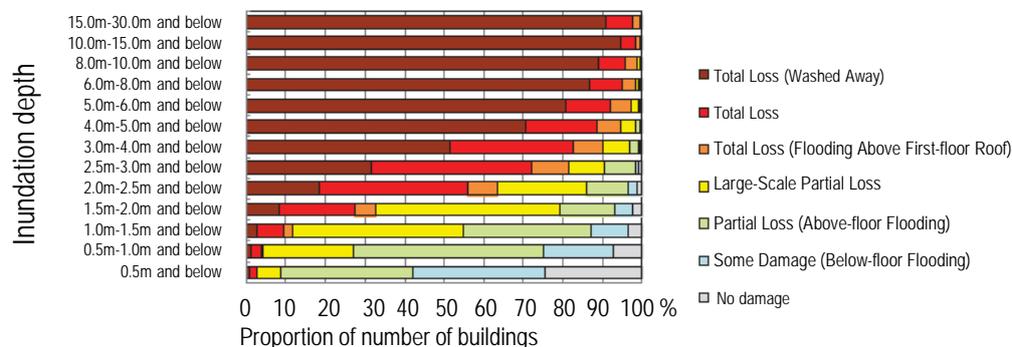
Our analysis showed a significant relationship between inundation depth and the condition of a building after a disaster. The proportion of buildings completely destroyed in the case of inundation depth of 2 m or below tend to be significantly lower than above that value (Fig. 2.31). Building type also has a significant role, Fig. 2.32. The proportion of buildings completely destroyed was 5% in the case of reinforced concrete structures for inundation depth 1.5 m – 2m. In contrast, at least 20% of wooden structures were completely destroyed at this depth, which is not necessarily a low proportion.

Fig. 2.31 Proportion of affected buildings with respect to inundation depth (City Bureau, MLIT, 2012).

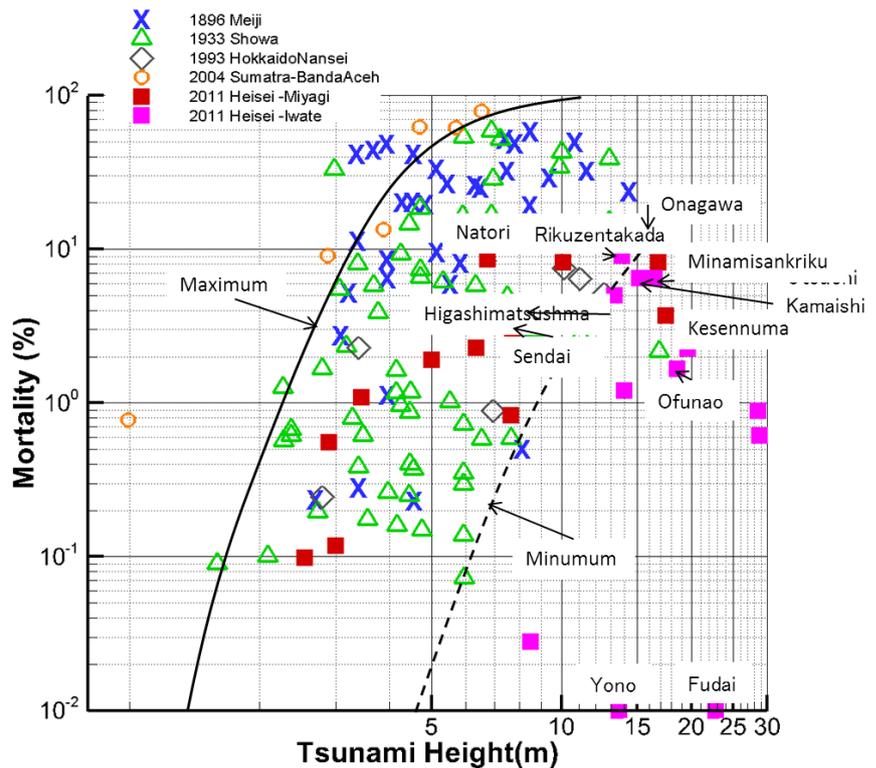
Fig. 2.33 shows the relation between the tsunami height and casualty rate. These were calculated by dividing the total number of casualties (including both fatalities and missing persons) into the population of each inundated area. The data include not only 2011 tsunami but multiple previous tsunami events. This figure indicates that the casualty rate of Iwate prefecture is much smaller than the other cases. There, the tsunami preparedness education was more effective, and the hazard mapping was more in-depth and accurate. In comparison, the casualty rate in Miyagi prefecture was larger than that of Iwate prefecture. Some suggested explanations include differences in topography or hazard map accuracy. In Miyagi prefecture, the hazard map in many area underestimated inundation area. This comparison indicates that the preparedness of vulnerable populations is very important.

Fig. 2.33 Relationship between tsunami height and casualty rate.
